Home Inspection Report

123 Main Street
Anytown, NY 12345

Prepared for: John and Jane Doe

Prepared by: Advanced Home Inspections
PO Box 16380
Rochester, NY 14616
www.advancedinspections.com
585-392-5354

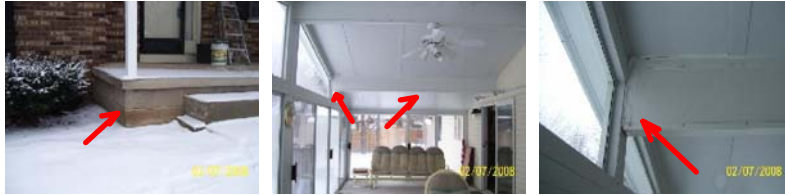
- 1. Driveway: Asphalt
- 2. Walks: Snow Covered
- 3. Steps/Stoops: Concrete/Wood
- 4. Porch: Enclosed/open Settling at support beams-monitor for future movement/front open porch entry showing settlement signs-monitor for future movement

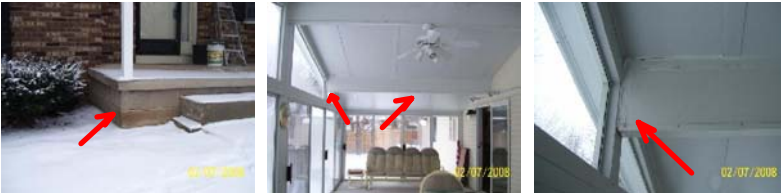
1. **Porch:** Enclosed/open Settling at support beams-monitor for future movement/front open porch entry showing settlement signs-monitor for future movement
